# Manhole Inspection Summary

Manhole # S45W\_\_001MH

Insp Date: **3/13/09 10:29 AM**

**Location** Address: **rear 1437 towson st**

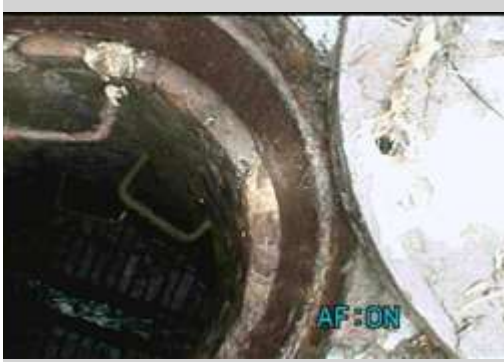
Defect 4

**Frame** Offset: **2** (in.) Condition: ☒ Sound ☐ Cracked ☐ Leaks

offset

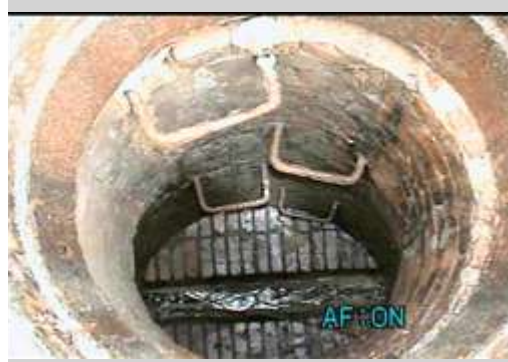
Defect 3

**Steps** Count: **4** Missing: **0** ☒ **Corroded**

corr steps

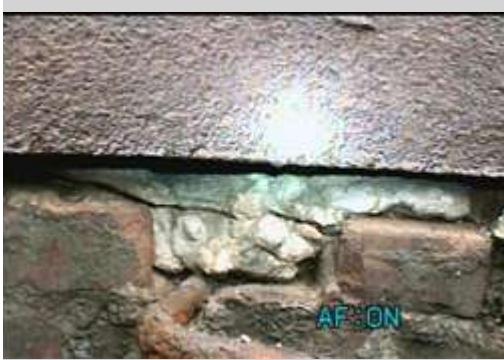
Defect 2

**Chimney / Frame Adjustment** ☒ Exists Material: **Brick and Concrete** ☐ Parged Height: **4** (in.)

Condition: ☐ Sound ☐ Cracked ☐ Root Intrusion ☐ Loose Brick ☒ **Deteriorated**

chimney deteriorated

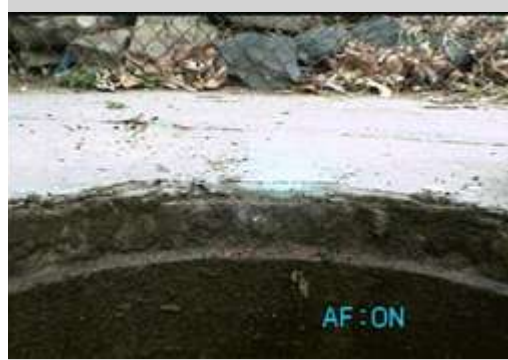
Defect 1

**Cover** Shape: **Circular** Diameter: **26** (in.) Length: **0** (in.) Dist A/B Grade: **-1** (in.)

below grade

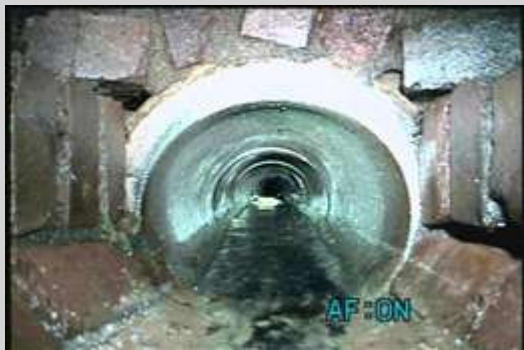
12 O'Clock Outflow

8 in. Circular Gravity Sewer  
Pipe Out @ 12 O'Clock

Invert Depth: **8.41** (ft.) Flow Characteristics: **Fast**

Infiltration: **None** Pipe Seal Cond: **Unknown**

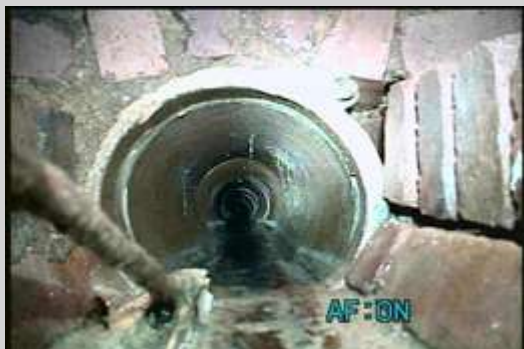
6 O'Clock Inflow

8 in. Circular Gravity Sewer  
Pipe In @ 6 O'Clock

Invert Depth: **8.33** (ft.) Flow Characteristics: **Fast**

Infiltration: **None** Pipe Seal Cond: **Unknown**
